# Naomi Freshwater Diversion

- Non-CWPPRA (75% State – 25% Parish)
- Completed February 1993
- Location:

Project No. BA-03

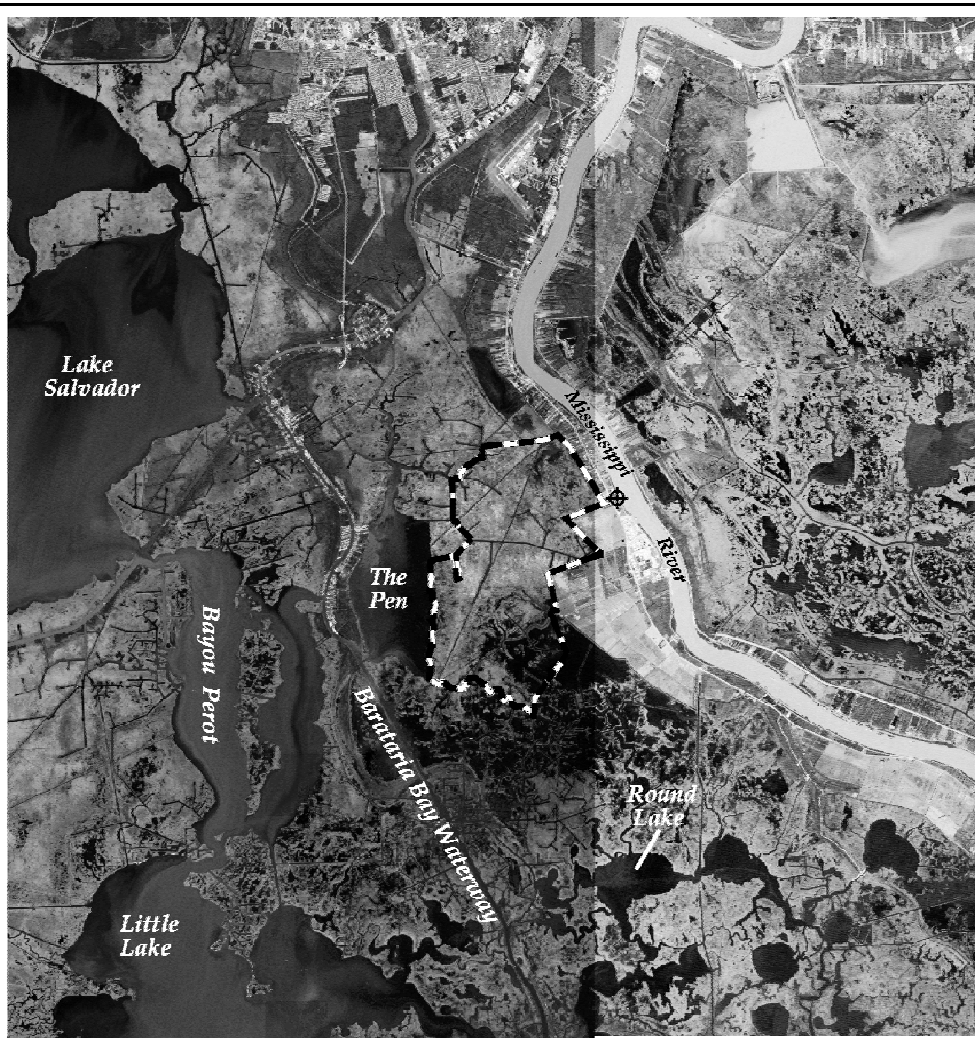
# Project Location

1994 Satellite Imagery

⊕ Siphon Location  
BA-03 Project Unit Boundary
